Training session Pulsation & Vibration Control

Newly commissioned reciprocating system showing vibration issues throughout, including shed

Root cause analysis

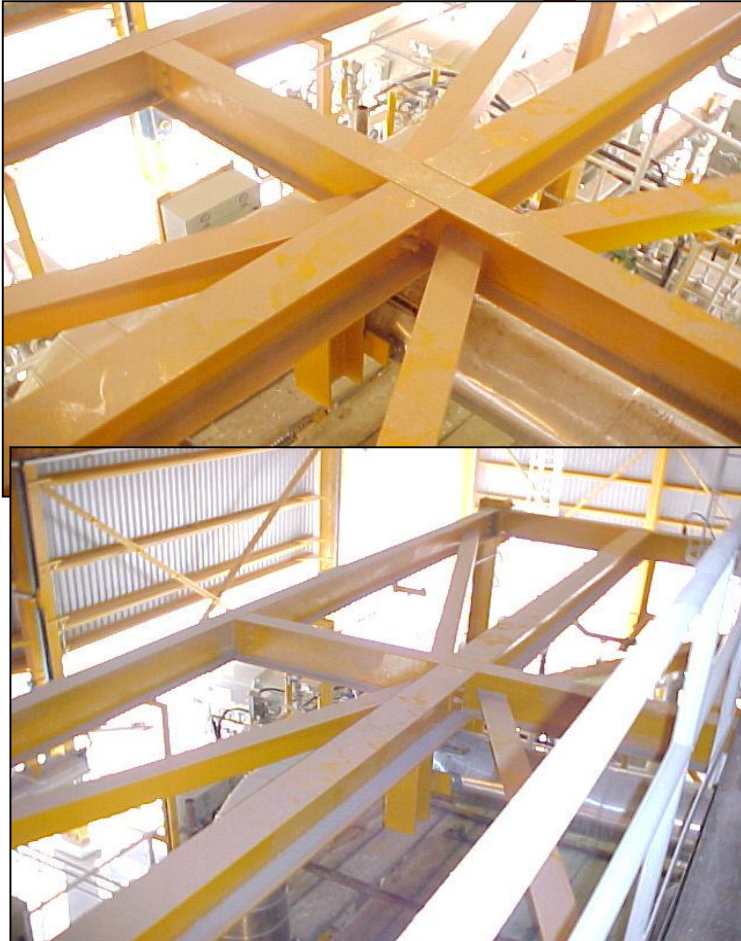
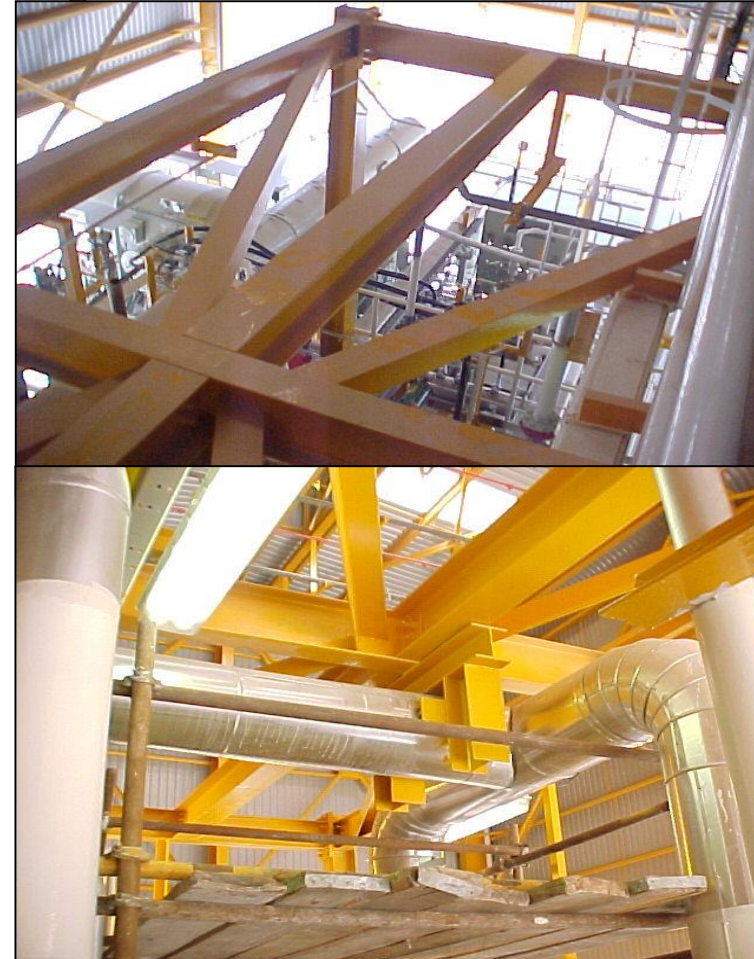
Piping well supported and axial restrained throughout the system

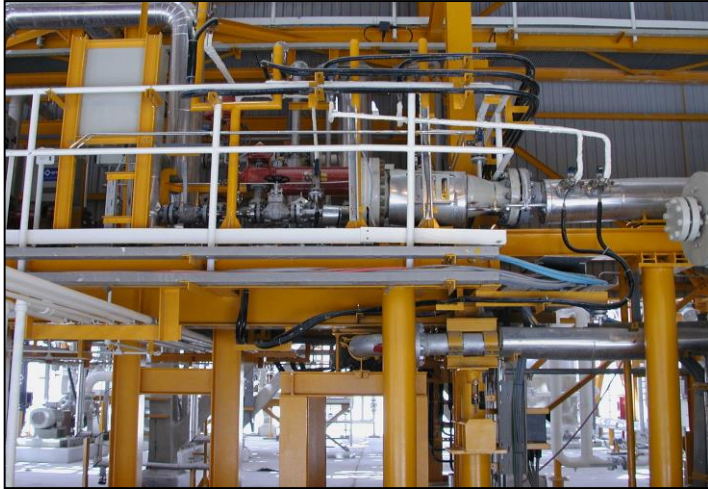
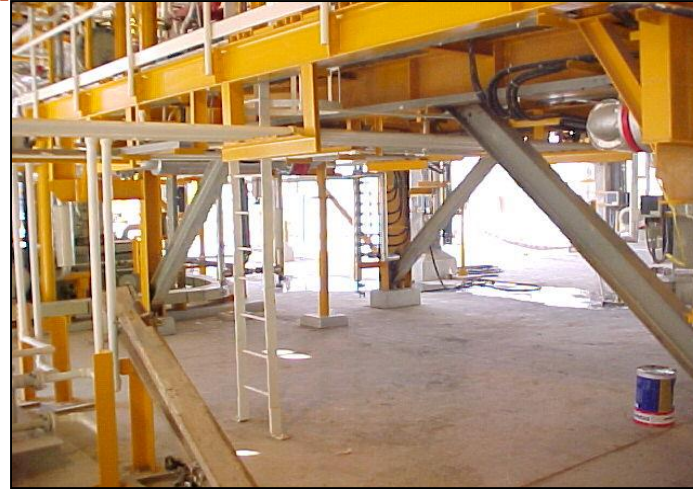
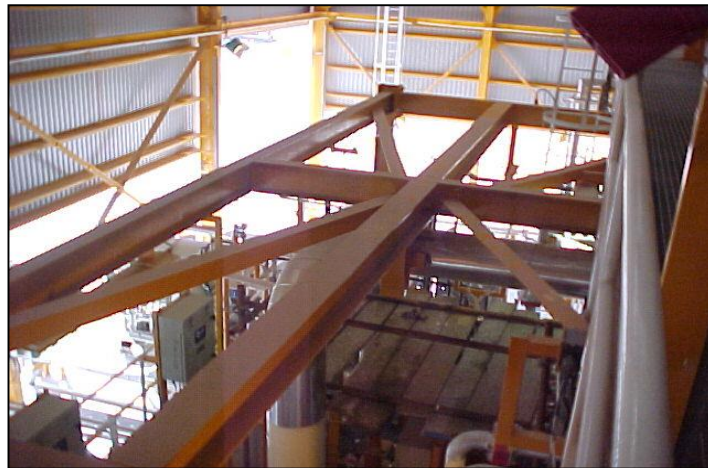
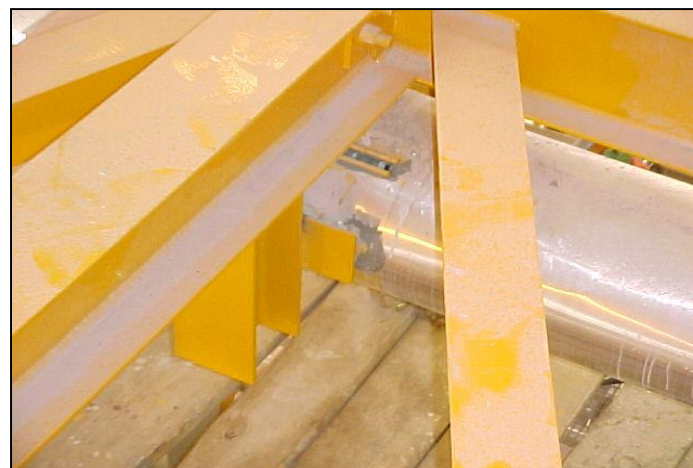
Piping supported on rack, steel was already added after commissioning (no success)

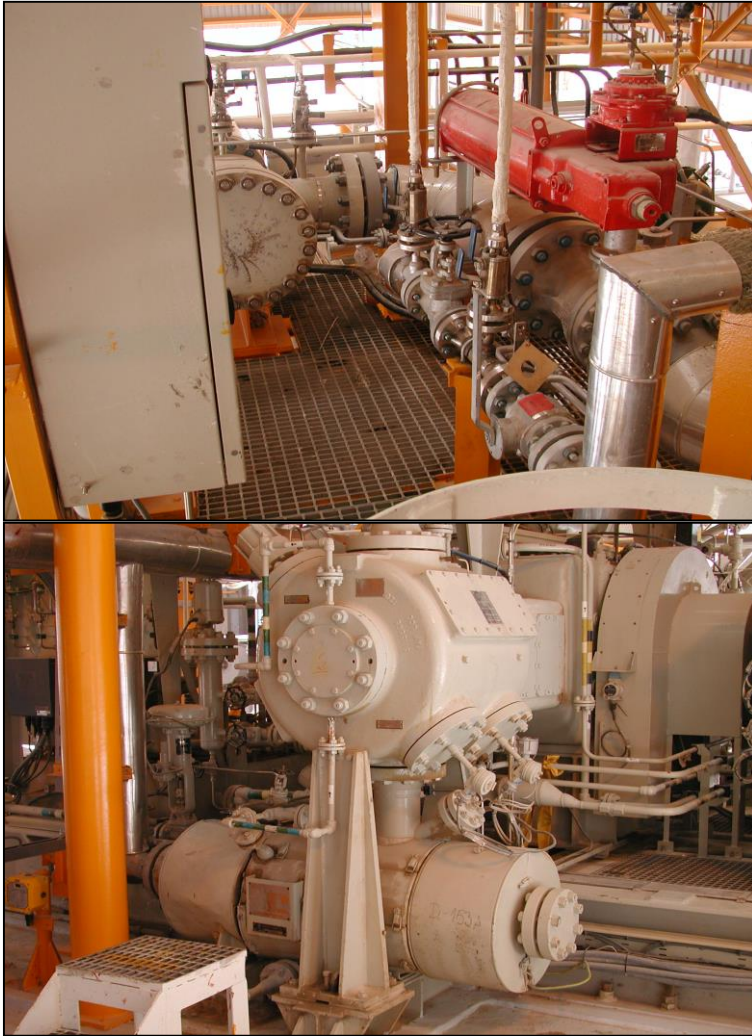
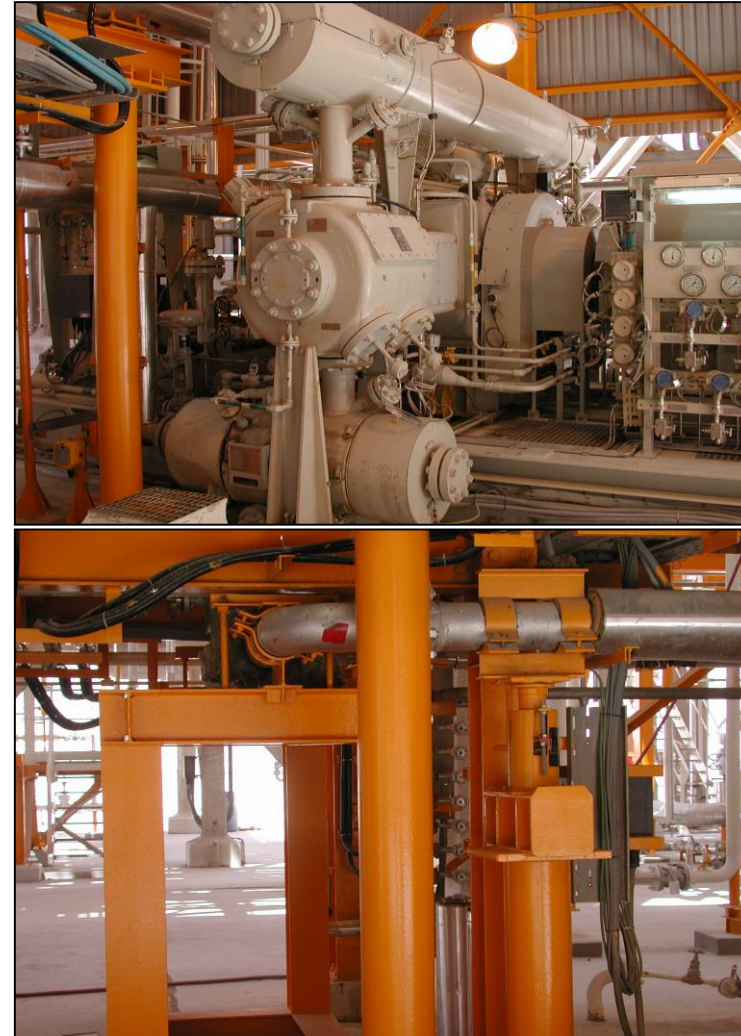
Cylinders well supported (no significant vibrations)

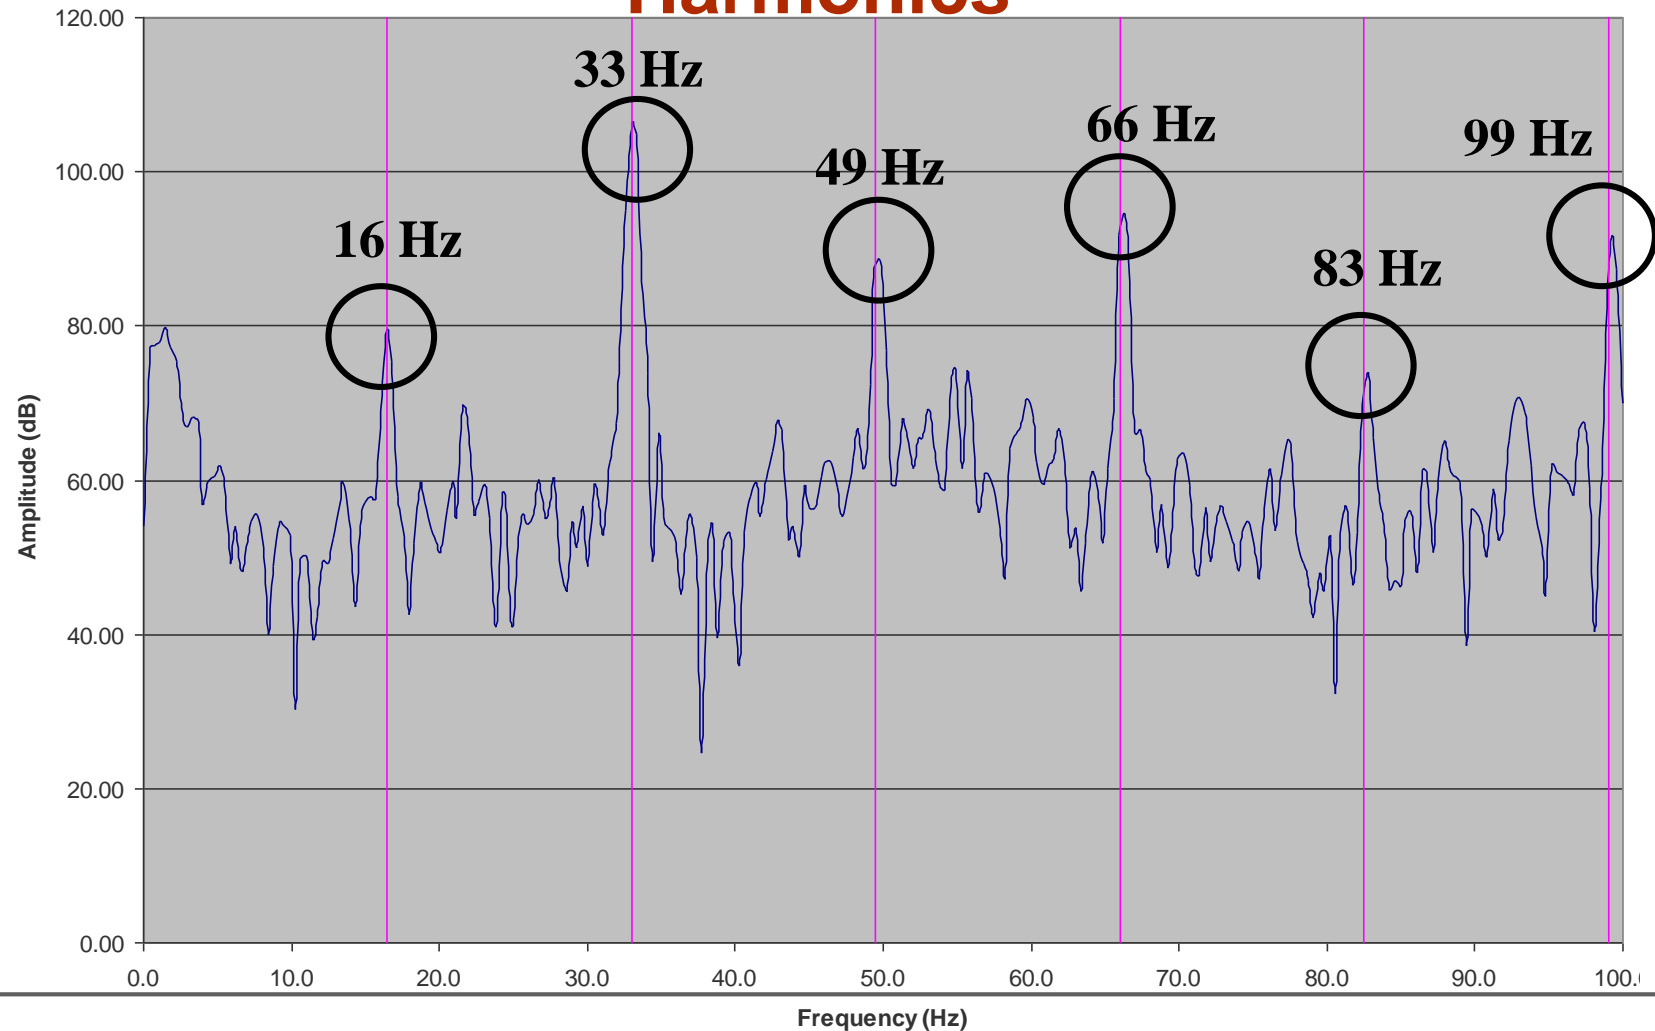
Step 1. Vibration Measurements and Compressor Harmonics

Vibrations are at compressor harmonics

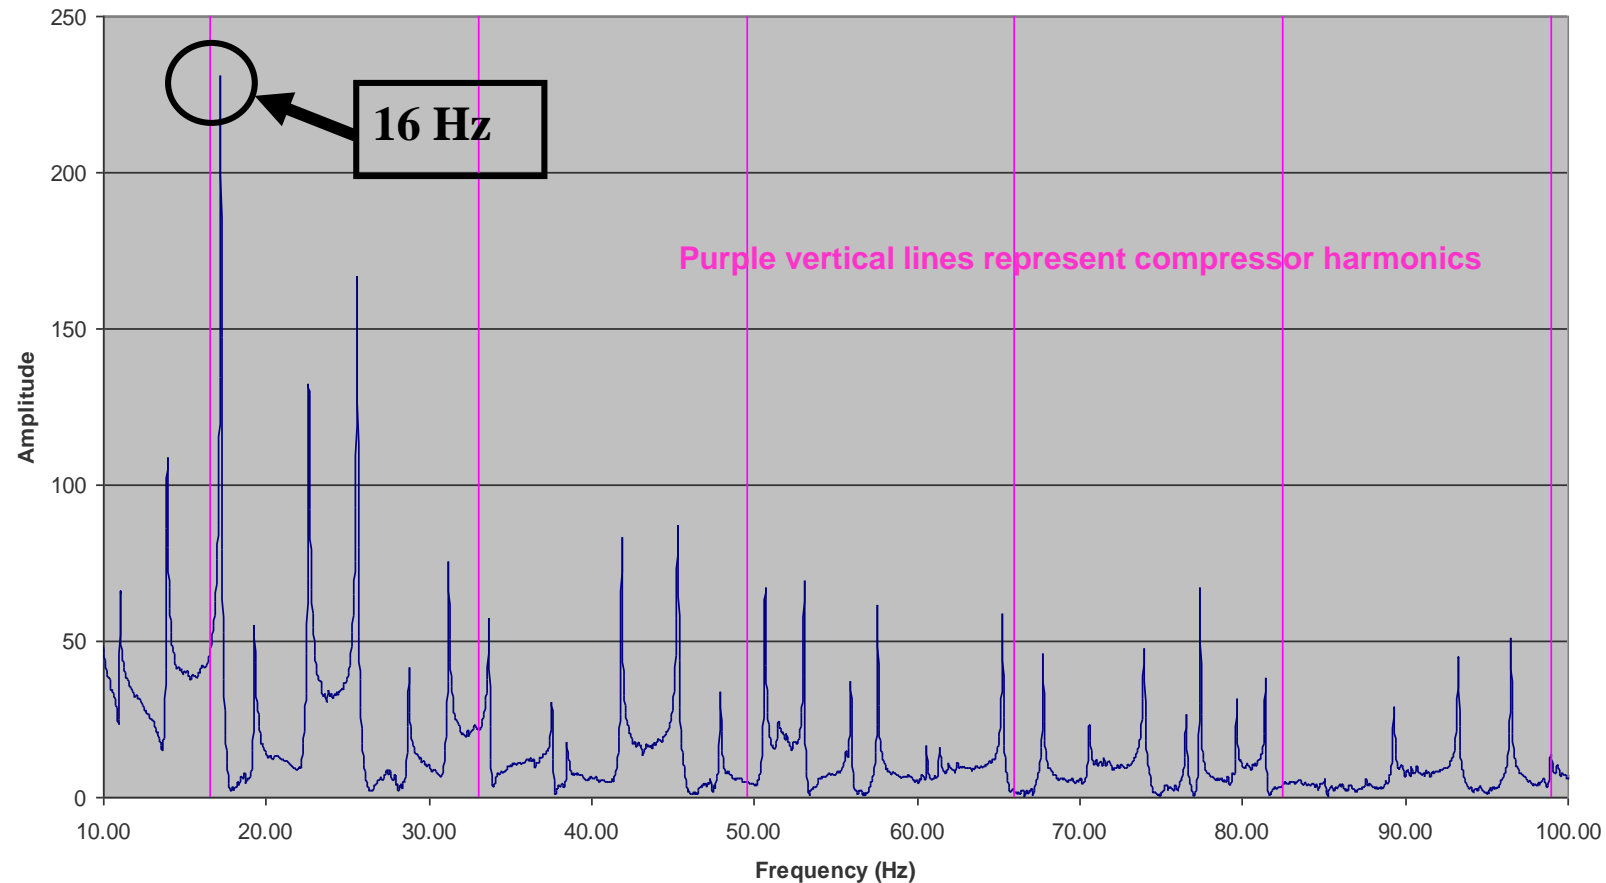
Step 2. Acoustical Natural Frequencies only show resonance mode around first harmonic (excluding bottle)

Most probably acoustic resonance condition at first compressor harmonic (16.5 Hz).

Vibration peak at 16.5 Hz, most probably is due high shaking forces as a result of near acoustic resonant condition.

- I.e. different bottles and/or orifice plates to introduce more damping

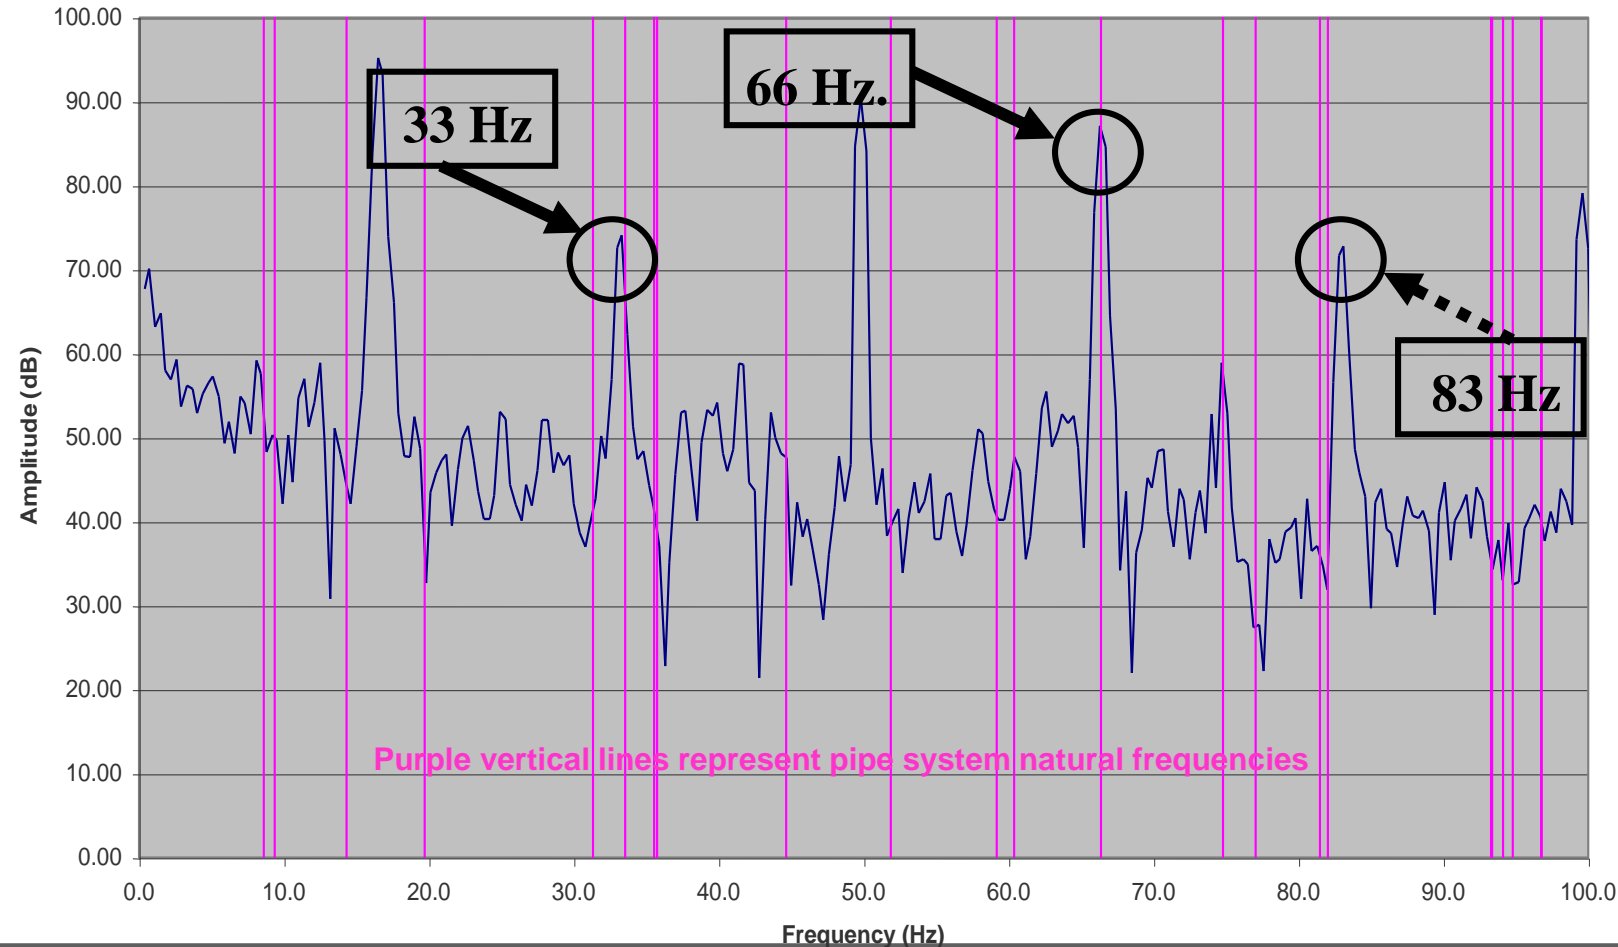
Step 3. Vibration Measurements & Calculated Mech. Natural Frequencies (Search for Mechanical Resonance)

Mechanical resonance likely at 33 Hz, 66 Hz and 83 Hz.

No mechanical resonance condition at the first harmonic (16.5 Hz.) and at 49 Hz. and 99 Hz.

- Mechanical nature vibrations at 33 Hz, 66 Hz and 83 Hz.
- Acoustic resonance problem at 16.5 Hz
- High pulsations forces without acoustic or mechanical resonance at 49 Hz and 99 Hz (compressor bottle sizing problem)

- Better supporting
- Improved support stiffness

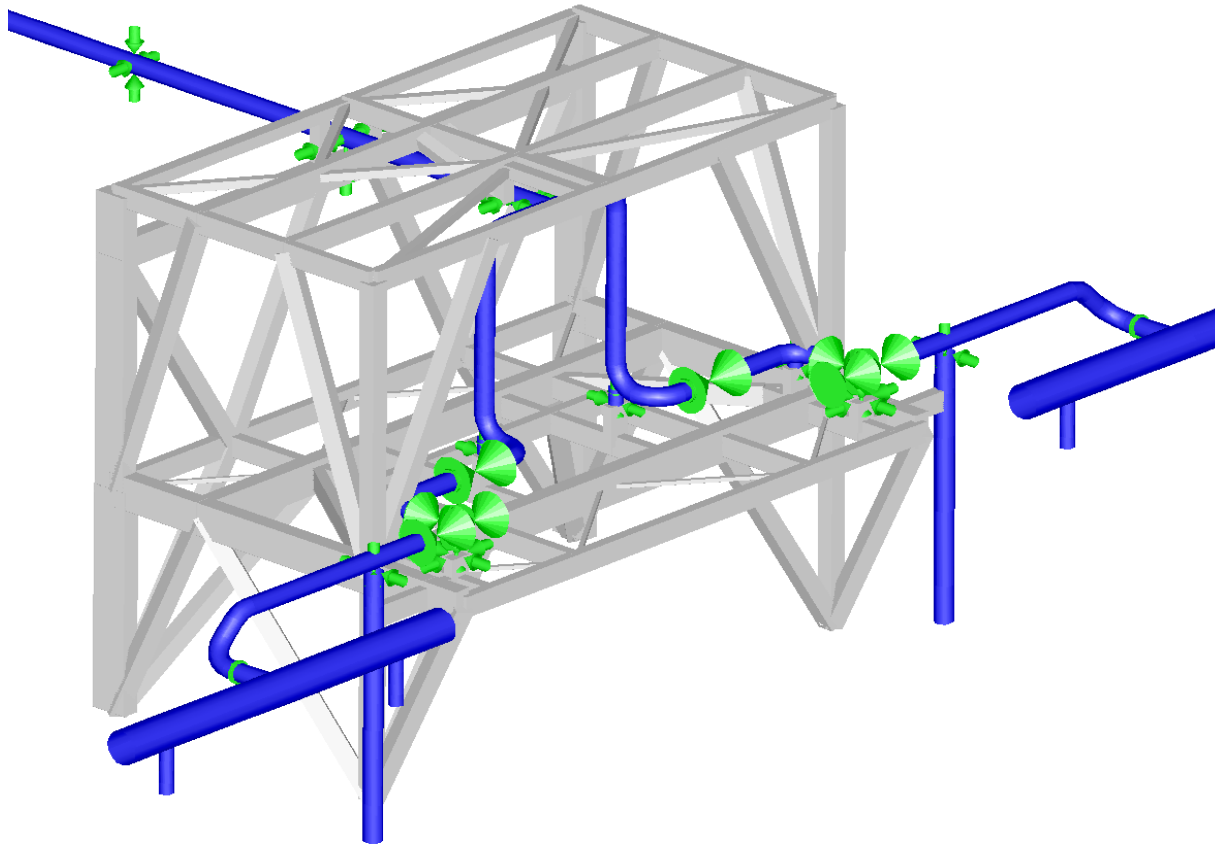
Modified Structure Implemented & Connected to Attached Piping

After implementation of structural changes, vibrations were drastically reduced.
