# EFRC Training Workshop

## Design of Compressor Foundations

Foundation Repair and General Overhaul  
Harry Lankenau – NEAC Compressor Service

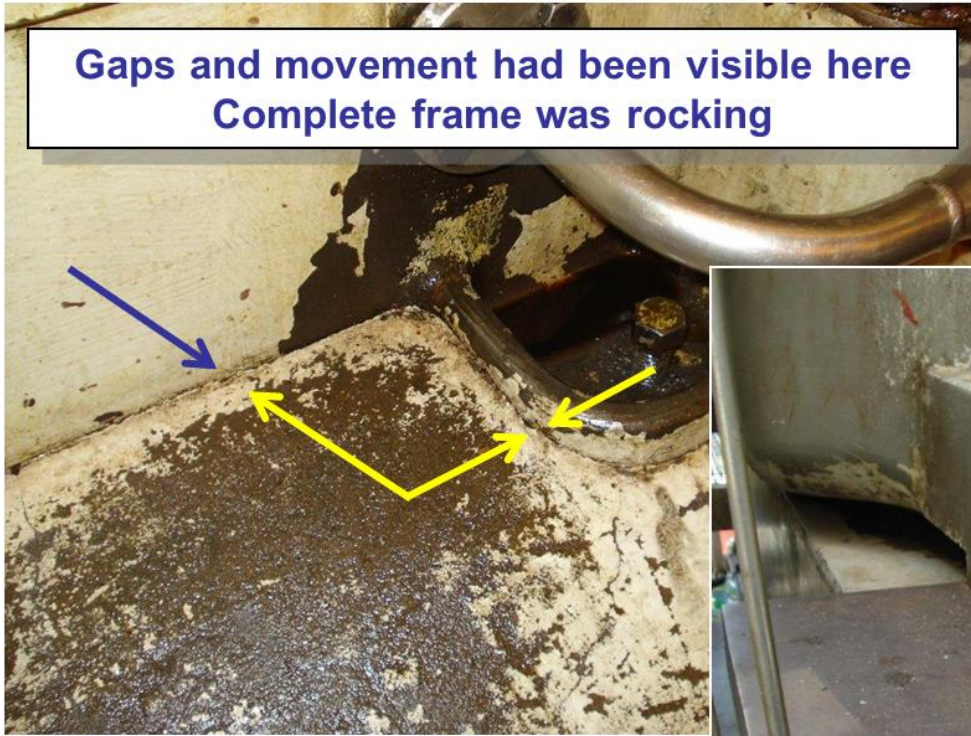
## Example No. 1

Gaps and movement had been visible here  
Complete frame was rocking

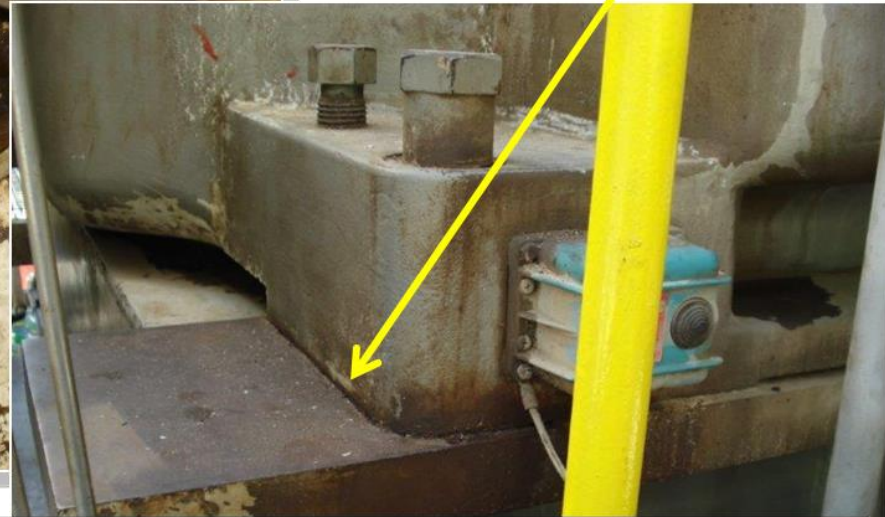
Sometimes oil or water bubbles indicate slight relative movement  
("Winking")

Some very small winking is normal or of no concern (due to the none infinite material stiffness)

Mobile vibration survey and monitoring may show if increasing

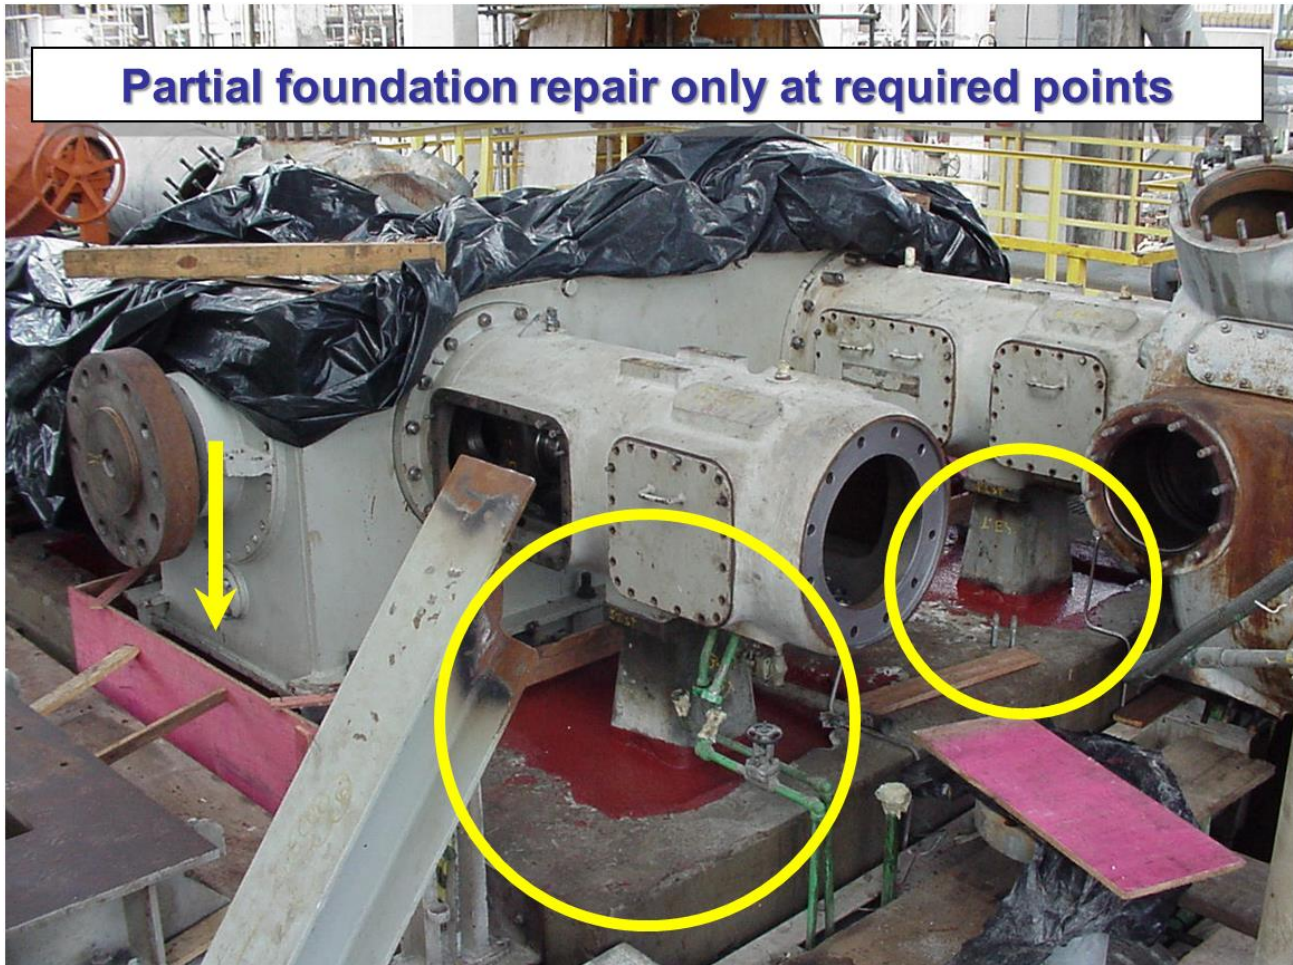
## Example No. 2

Partial foundation repair only at required points

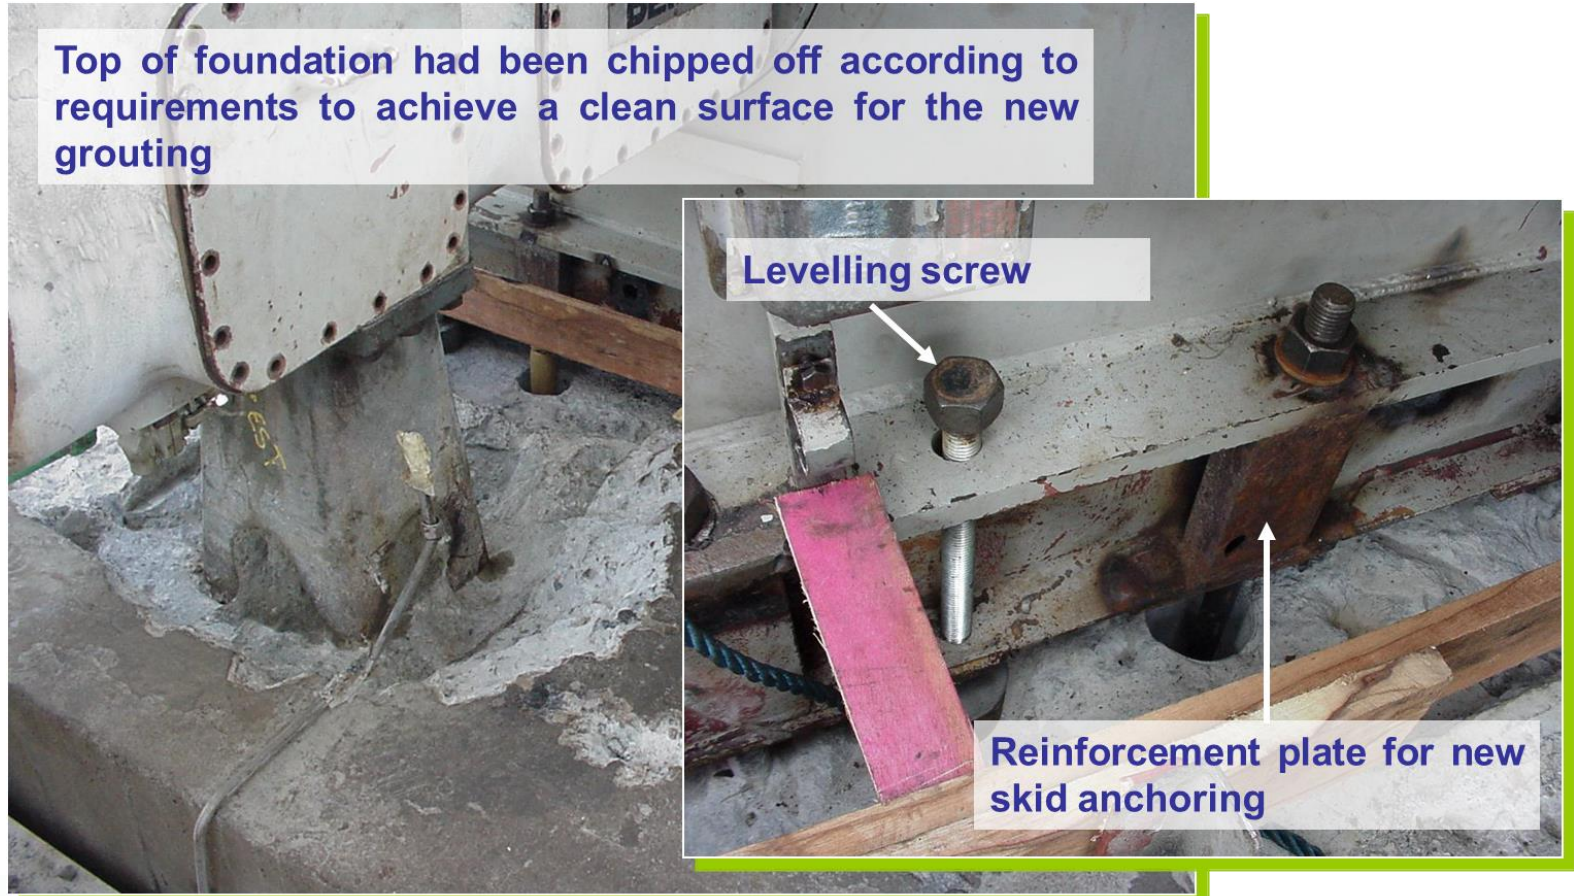
Top of foundation had been chipped off according to requirements to achieve a clean surface for the new grouting

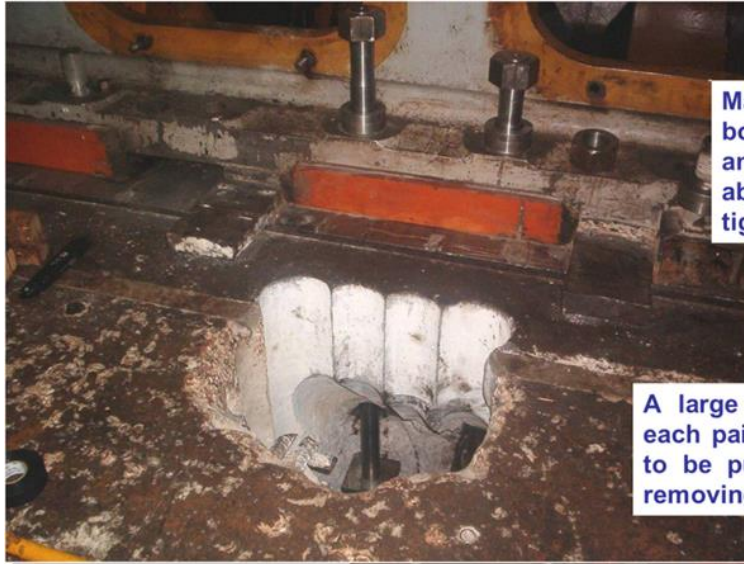
## Example No. 3

Machine frame anchor bolts had come loose and had no longer been able to hold the frame tight on the foundation

A large hole was drilled for each pair of new anchor bolts to be put in place – without removing the frame

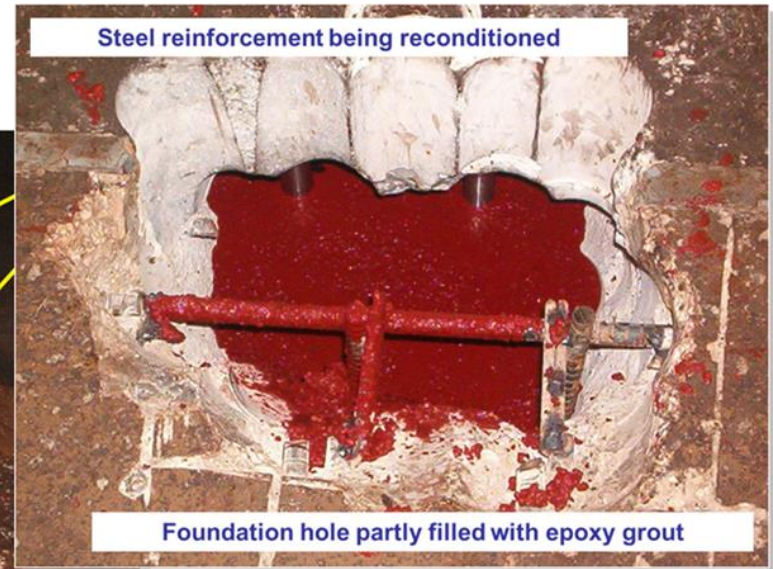
Steel reinforcement being reconditioned

Foundation hole partly filled with epoxy grout

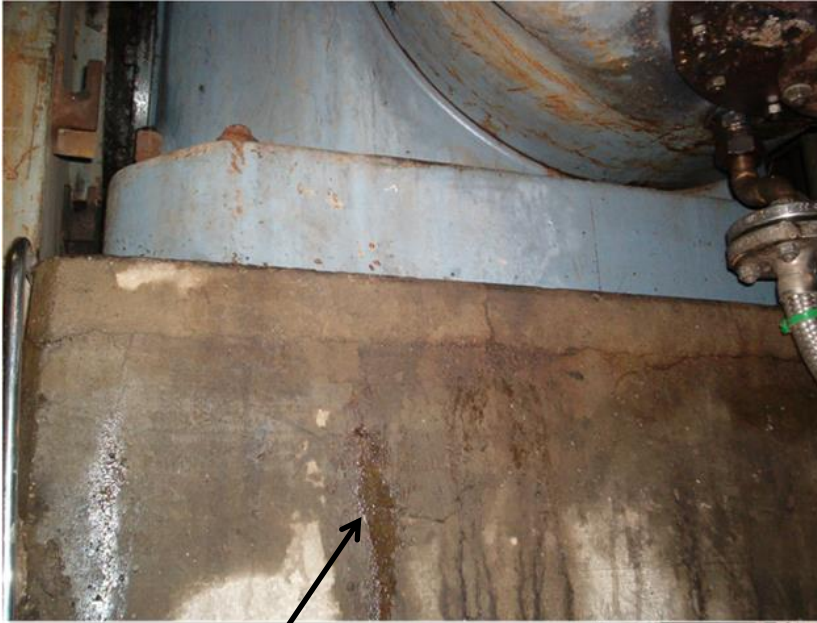
### Example No. 4

Oil emerging from lower section of the concrete foundation

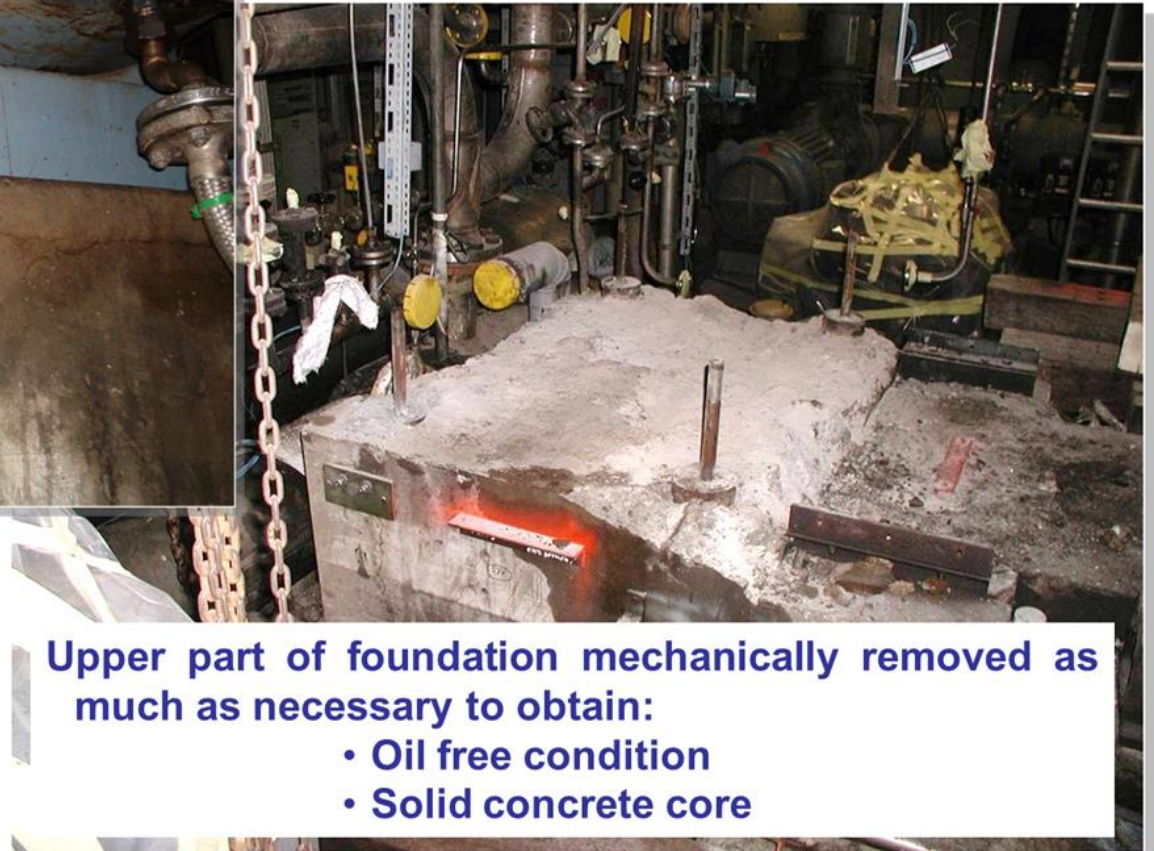
Upper part of foundation mechanically removed as much as necessary to obtain:

- Oil free condition
- Solid concrete core

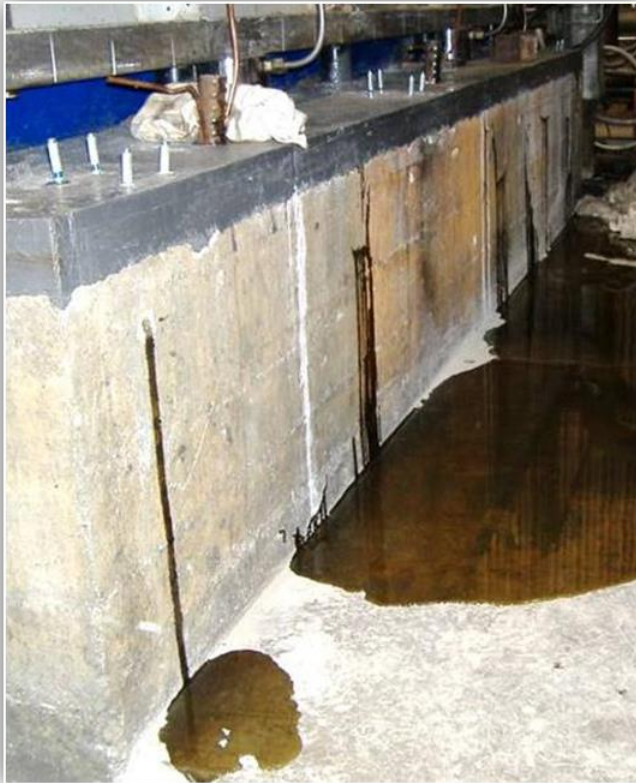
**Foundation Crack Repair by  
High Pressure Epoxy Injection**

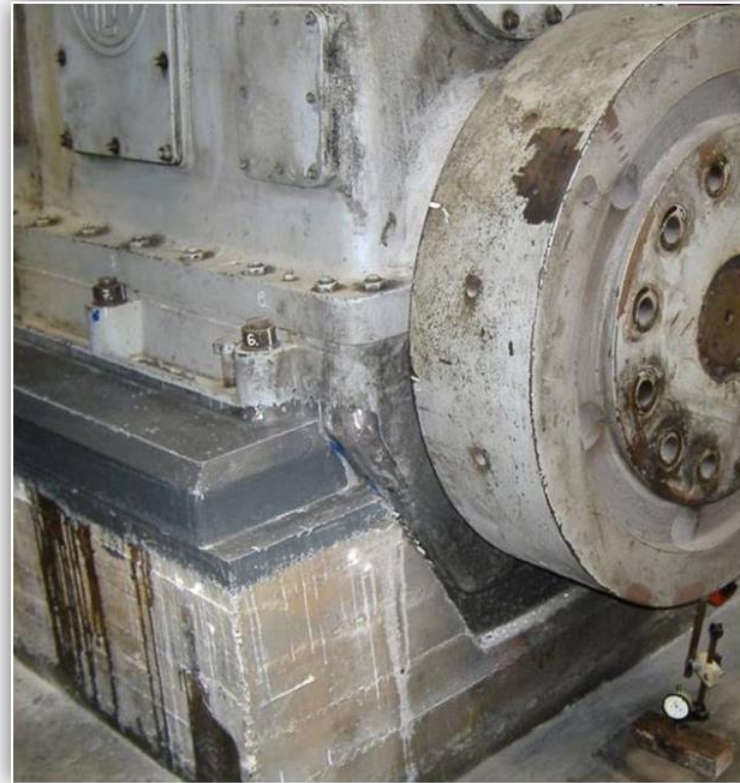
**Refurbished Foundation with new  
Epoxy Grouting – Fit for Purpose**

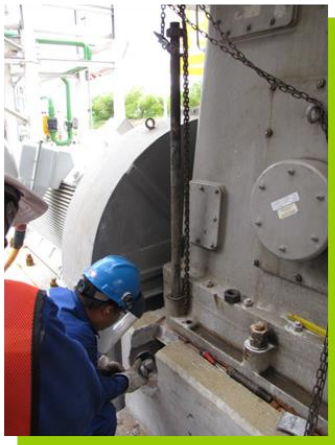
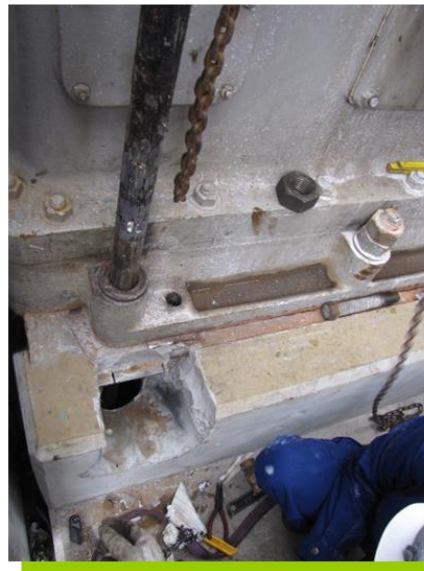
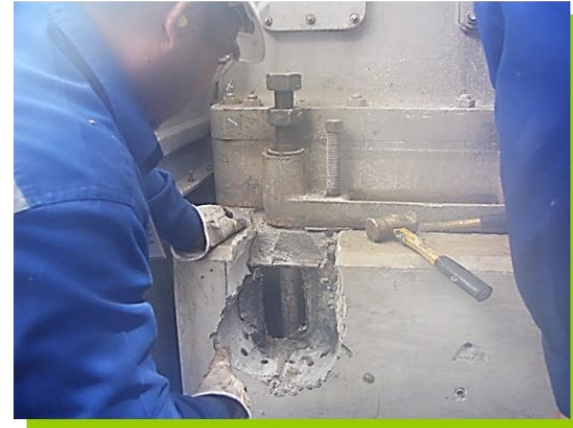
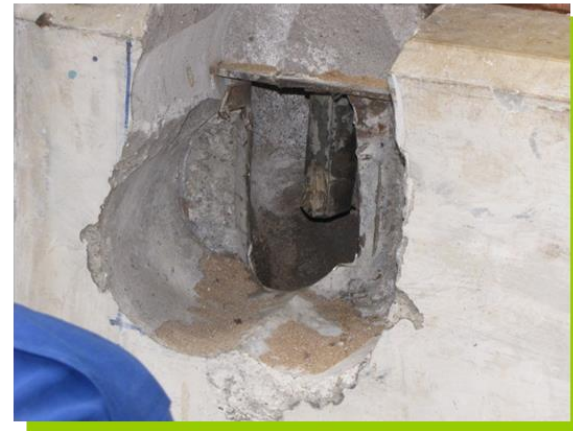
## Example No. 6

### Anchor Bolt Check

1. Partially cut off grouting and concrete
2. Open anchor sleeve
3. Pull anchor bolt

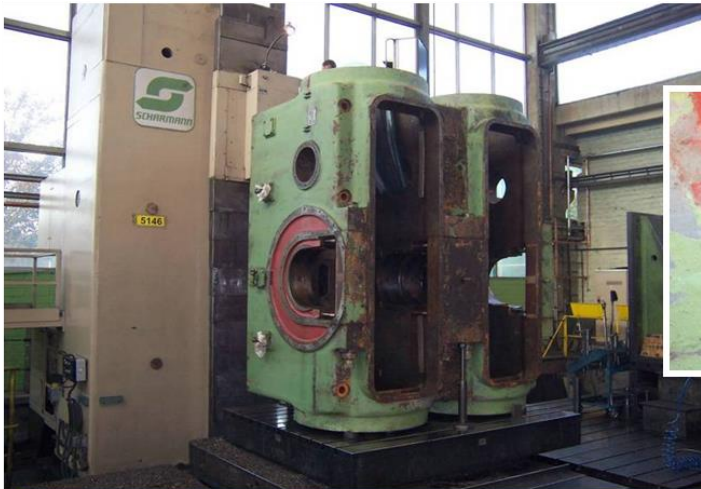
Hyper Frame set up on Milling Machine

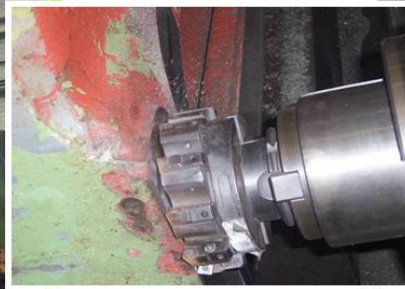
Milling head  
at work

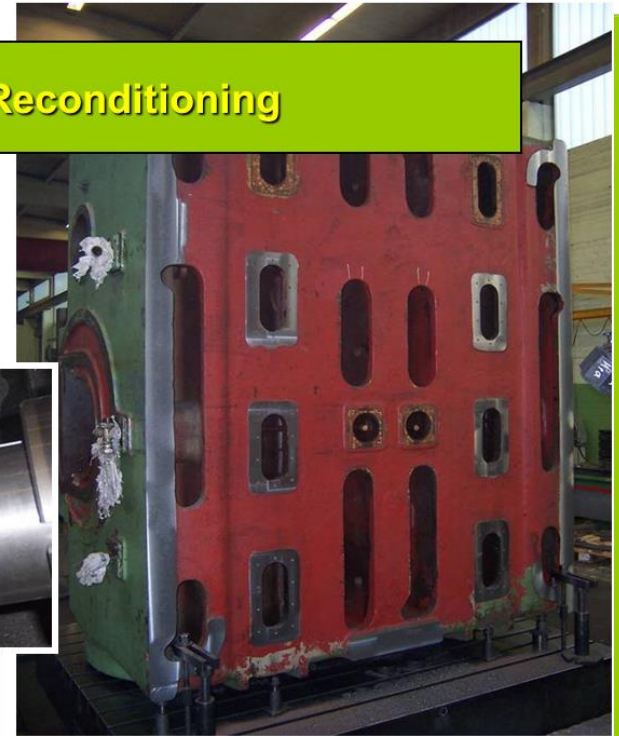
Crank Cased being reworked

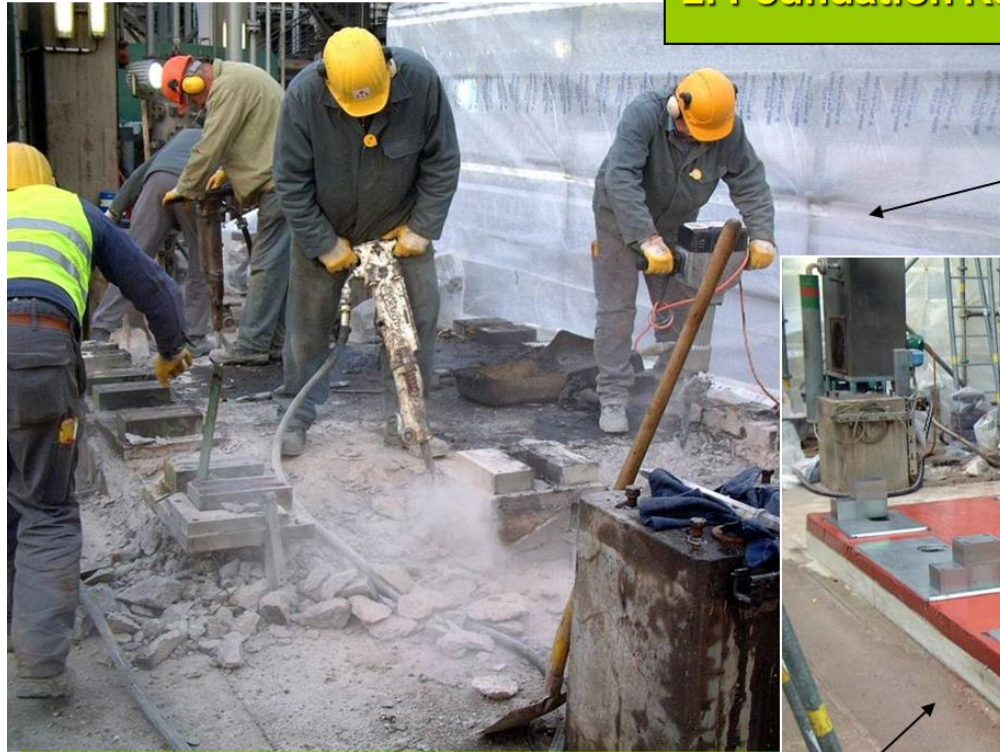
Most of the old concrete had to be removed ...

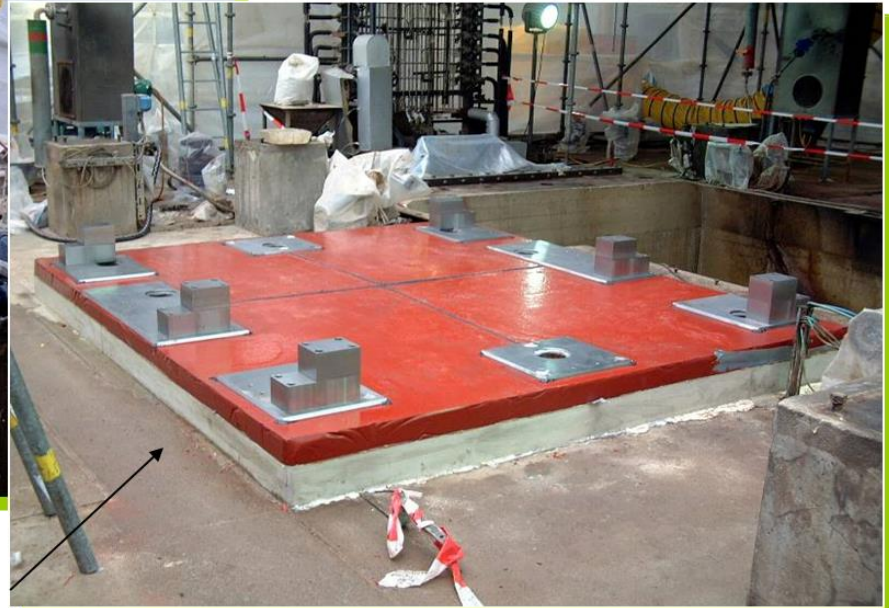
... and reconditioned by application of Epoxy Resin

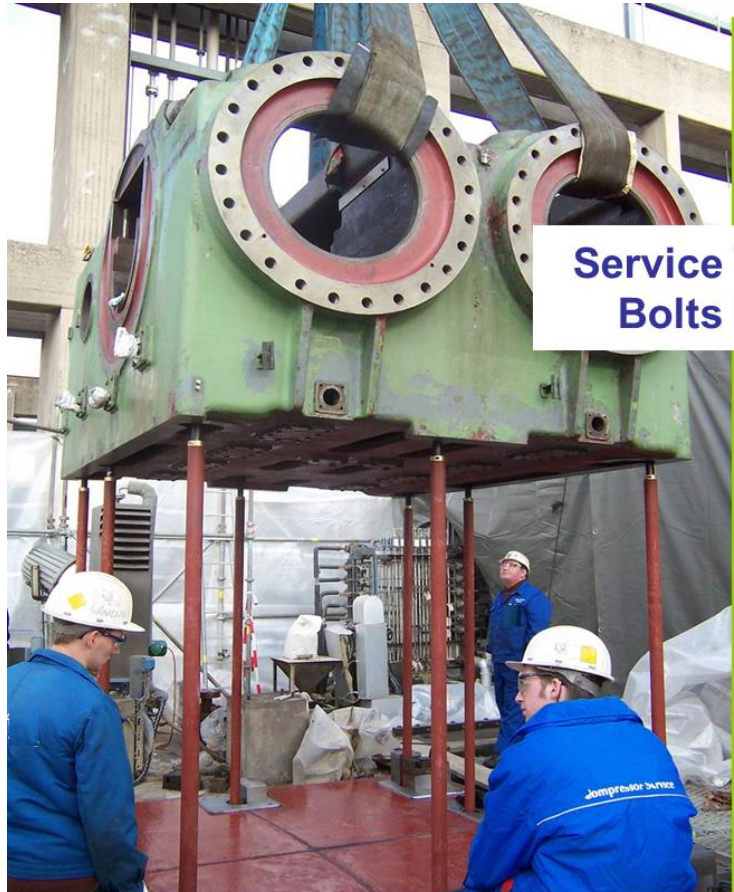
Service Technicians guiding the Anchor Bolts into their Foundation Sleeves

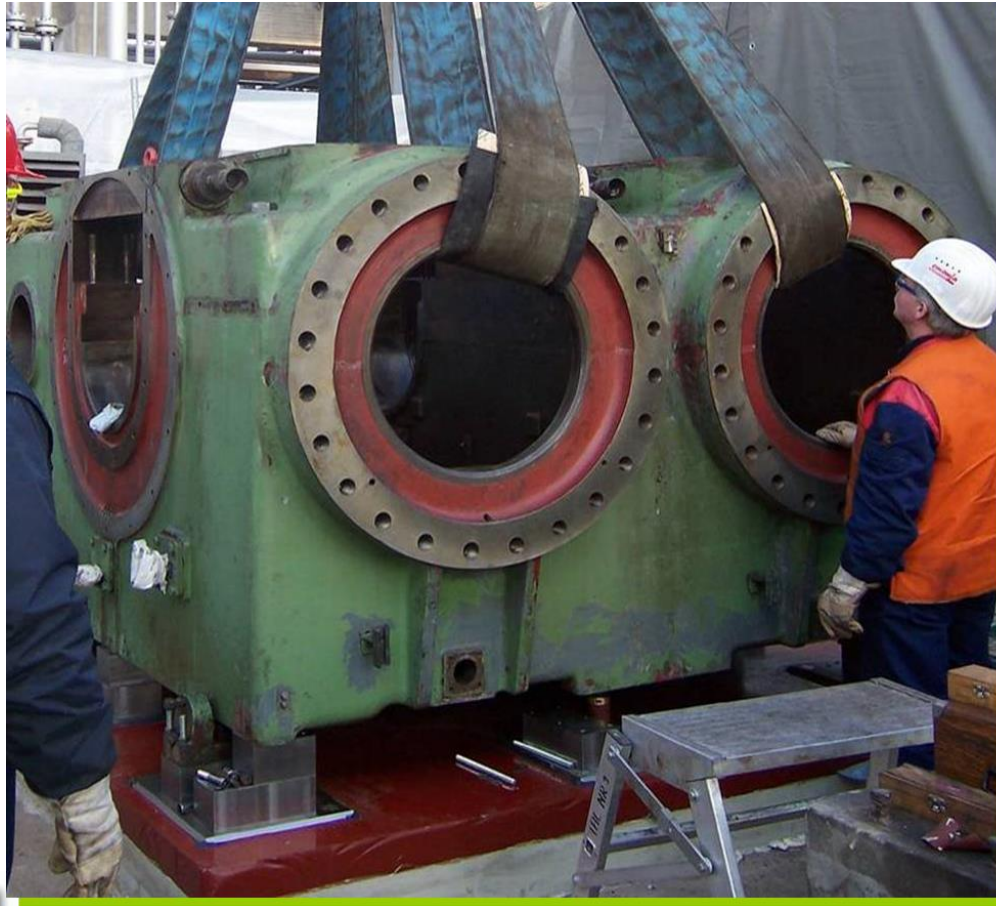
Frame close to touch base ...

... to get settled on its new bed

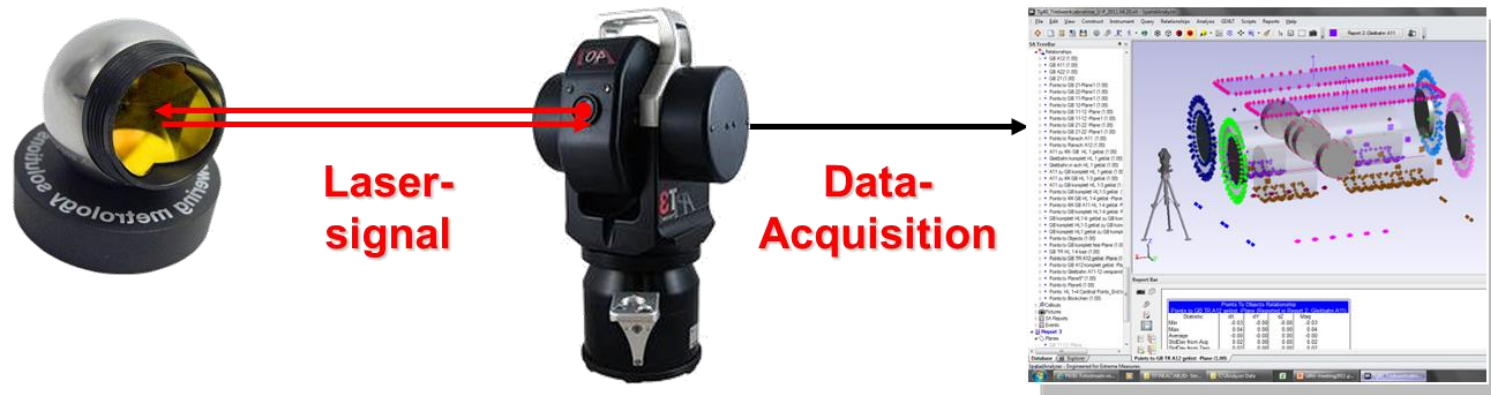
**Detector (SMR)**  
Mobile “Magic Eye”

... is held towards the object to be measured; it receives the laser beam from the tracker and reflects it back

**Transmitter  
(Laser Tracker)**  
Fixed

The tracker sends the laser beam to the reflective target – the “Magic Eye” prism mirror

**Notebook  
Computer**

... collects the coordinates of each point for data acquisition and evaluation through relevant software

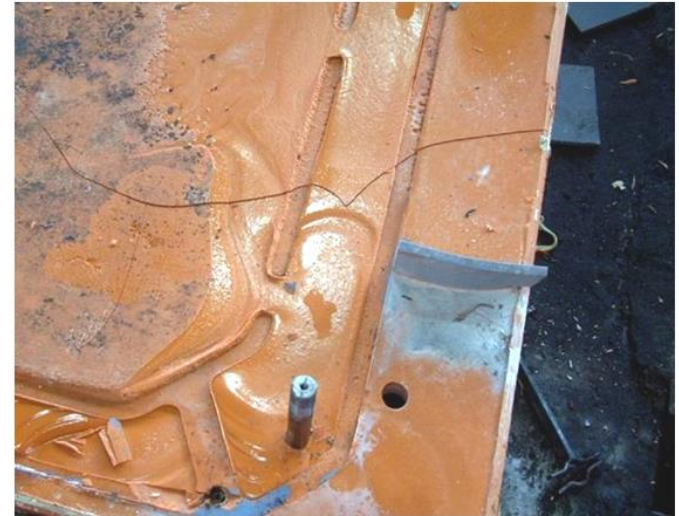
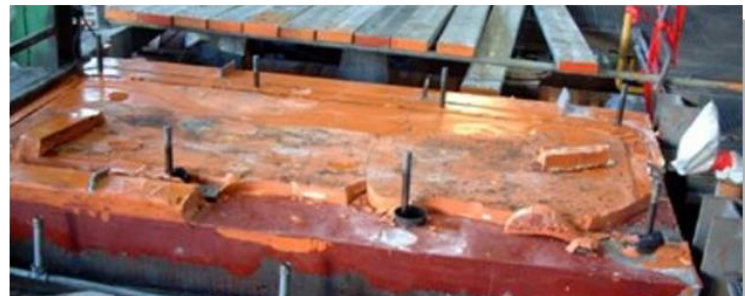
In case of incorrect application:

Possible causes:

- Too high temperature
- Wrong mixing
- Poor bonding – presumably due to inadequate surface treatment

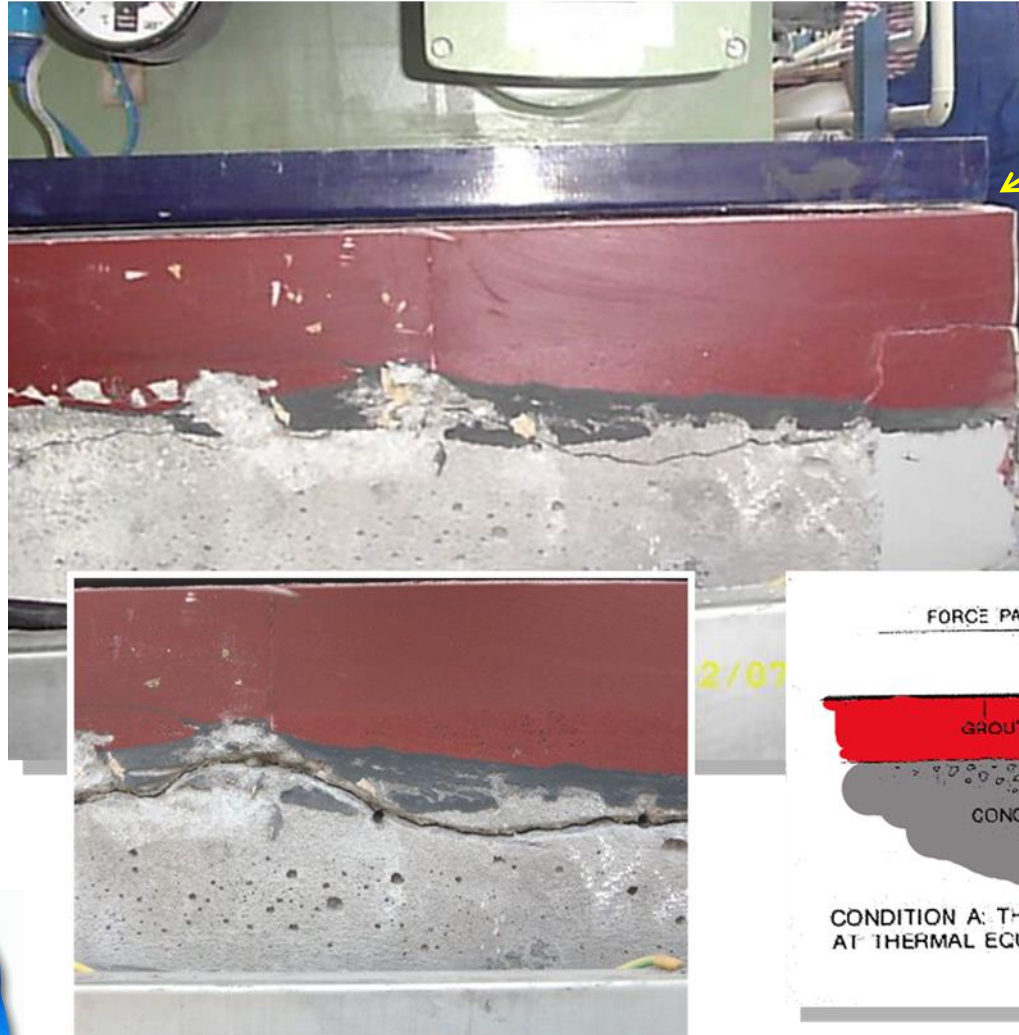
Potential reasons for grout lift up:

- Missing top weight (gap)
- Poor heat transfer from bad/no (top) contact
- High local grout temperature with partially fast curing and uneven expansion/contraction
- High temperature differential between grout and base
